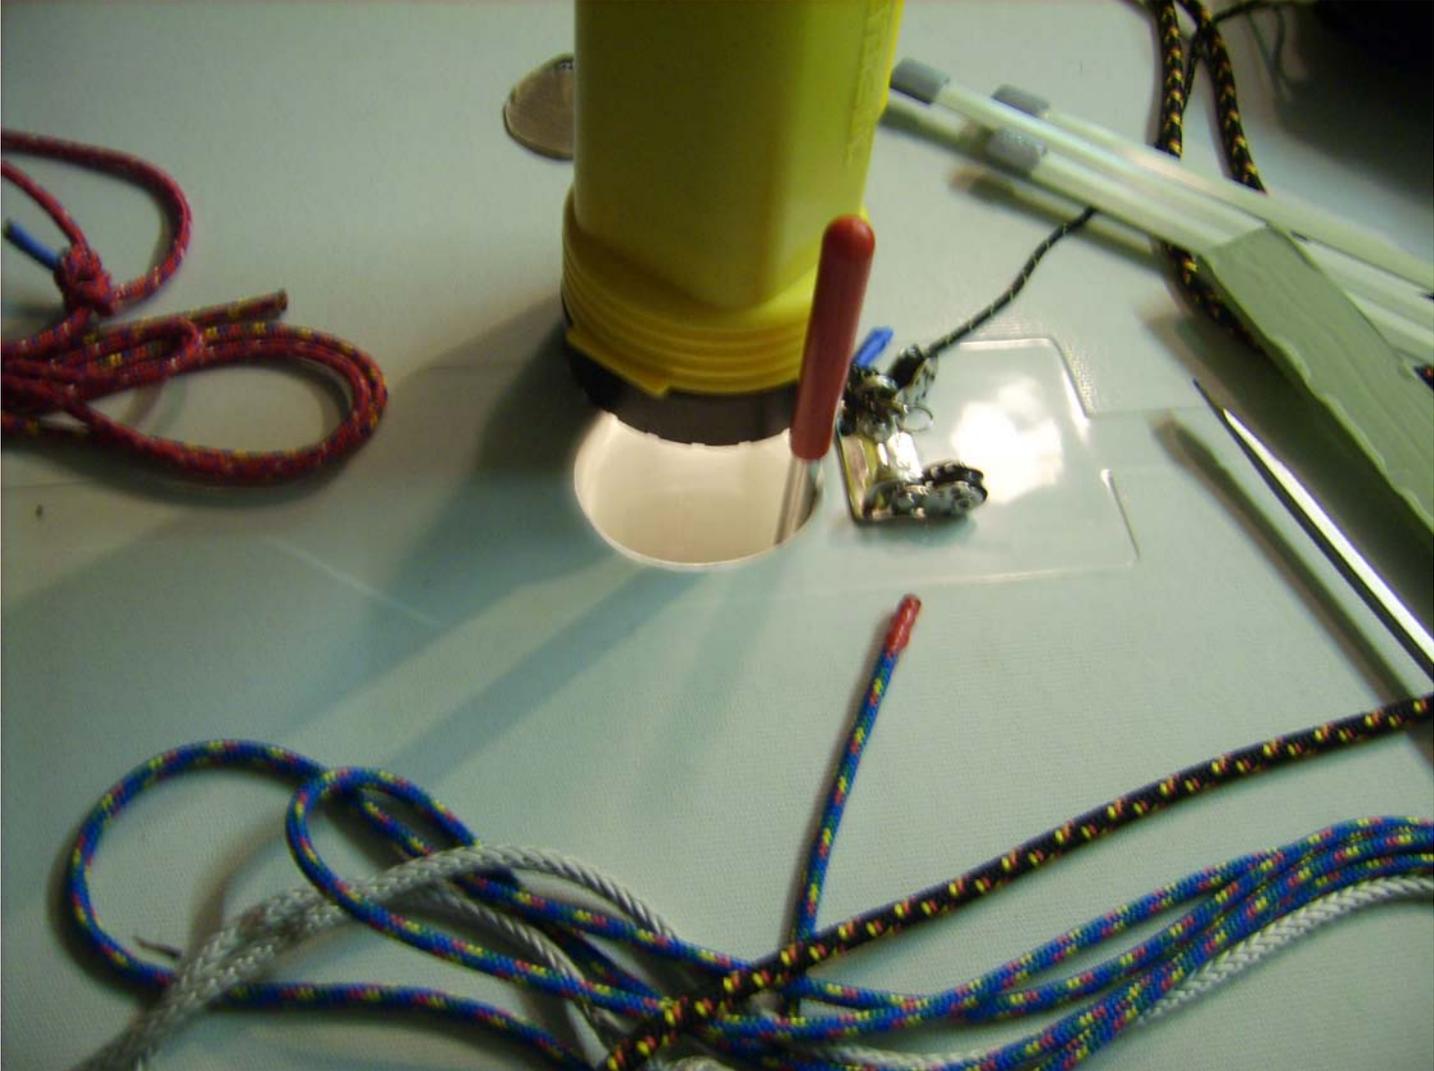
Figure 1: Overview of Top of Laser Mast Well. Flashlight and mirror to try and take photo of worn front bottom wall of mast well.

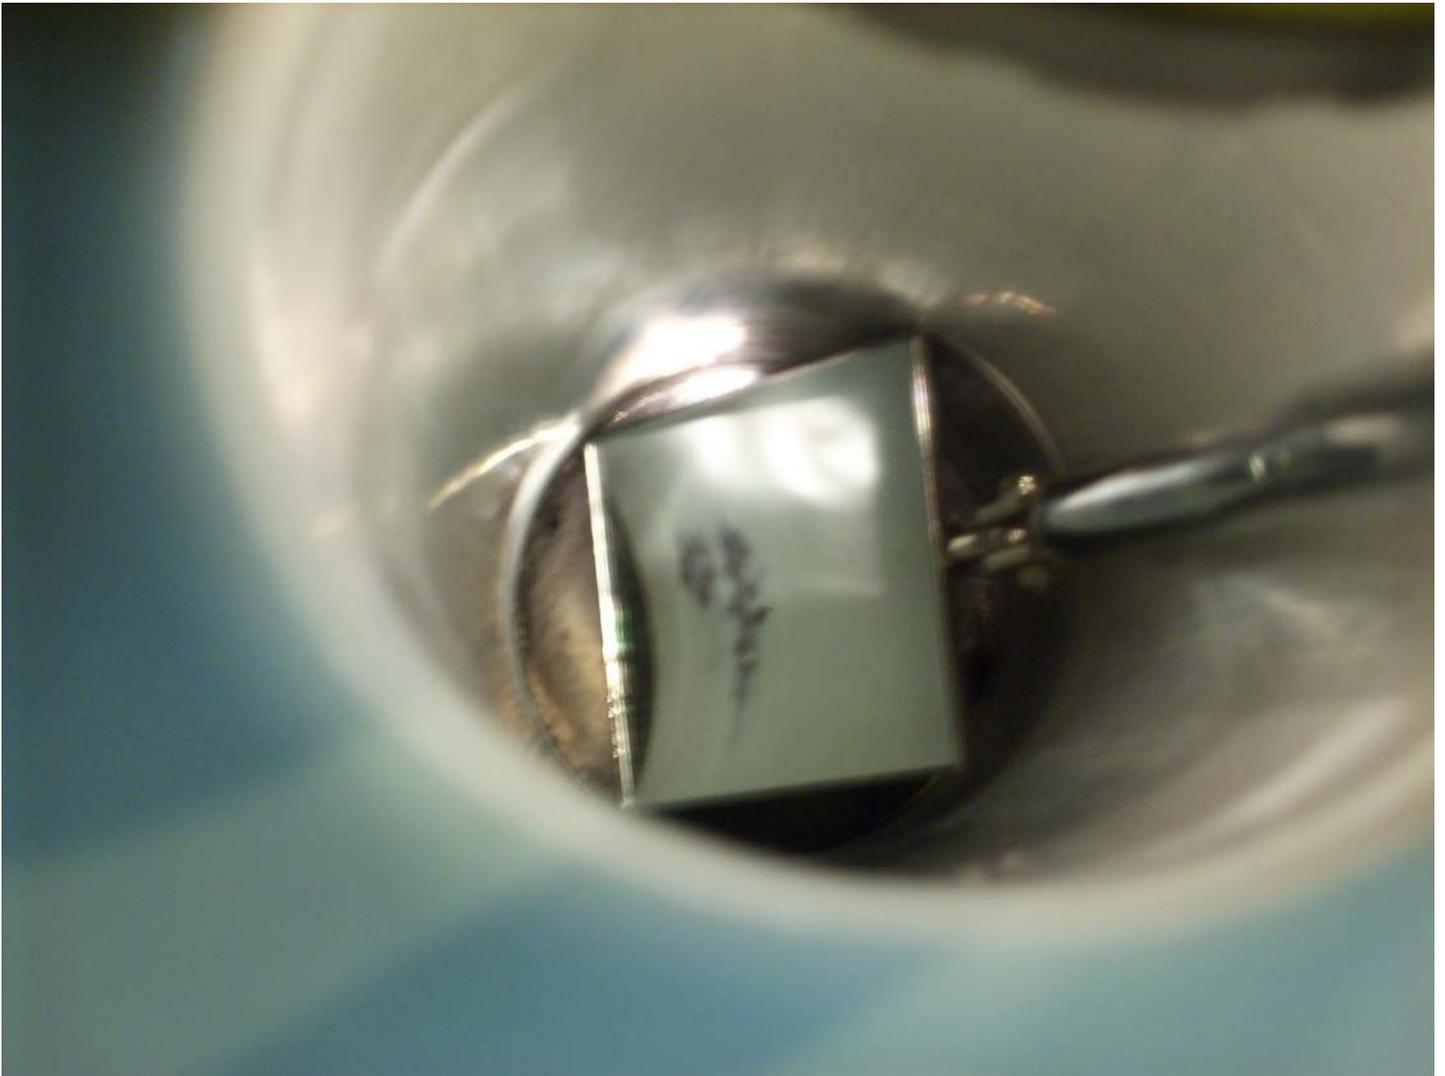
Figure 2: Mirror shows (somewhat) the rubbed off gelcoat on the front, bottom wall of the mast well. For now, just the gelcoat has been work off in this area. I am looking for a way to reseal, recover this worn area to prevent water from seeping/leaking into the now exposed fiberglass.
